CONCO SYSTEMS

IN THE TUBE

SPRING 2009 / VOL. 8

Midwest Power Plant Uses Eddy Current Testing To Prevent Costly Tube Failure

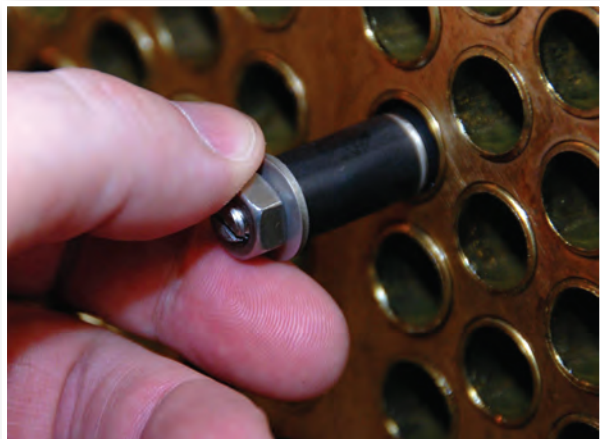
Tube plugging was performed in conjunction with eddy current testing.

The tubes were a lot worse than had been originally thought, many on the verge of failure. Using an 88% or more thru-wall condition as a guide, the plant proceeded to plug 348 tubes. This brought the total number of plugged tubes in the condenser to 2,540, which at 9.16%, was below the plant's 10% flow restriction guideline for the condenser. A die test was then performed, and the results showed that there were no more tube leaks in the condenser. Conco's color-coded tubesheet map also gave them a good guideline for what they have to do at the time of the next scheduled outage in 2010, as to whether they will have to plug or replace the aging tubes.

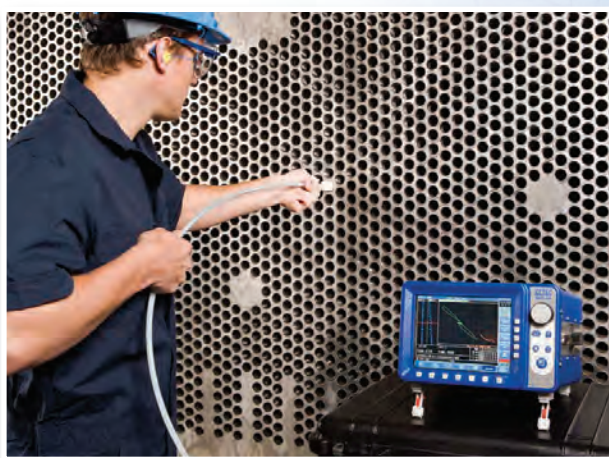
Technician using MIZ28 Data Acquisition Equipment.

Conco Eddy Current Testing Services utilizes the latest generation multi-frequency testing equipment, including the Zetec MIZ-28 digital acquisition testing unit that expands testing ranges into both the ultra-high and ultra-low frequency ranges. Conco also provides a multi-color tubesheet map for graphic illustration of tube wall condition, showing each tube's condition in a trend-specific color. It took about four weeks to eddy current test the entire condenser, and the results gave the plant the thru-wall damage percentage of every tube in the condenser.

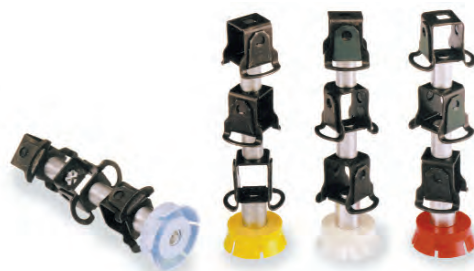
C3S Tube Cleaners

A Southern California Plant experienced degradation in condenser performance of as much as 0.40 in. Hg in one year's time, attributed largely to impeded tube flow in the condenser tubes. Using sample tubes removed from the condenser, the plant evaluated various cleaning methods; including high pressure water lancing, chemical, rubber pigs, brushes and Conco spring-loaded metal cleaners. Of all the methods evaluated, only the Conco cleaner was completely effective in removing all deposits. The Conco cleaners cleaned the tube surface to bare metal and polished the tube surface for minimum flow restrictions. Conco C35 tube cleaners were then used to clean all the plant's condenser tubes. The result indicated an improvement in turbine backpressure of 1.24 in. Hg at full load and a 2.10% heat rate improvement. The plant estimated that the condenser performance improvement yielded almost \$2 million in fuel savings as well.

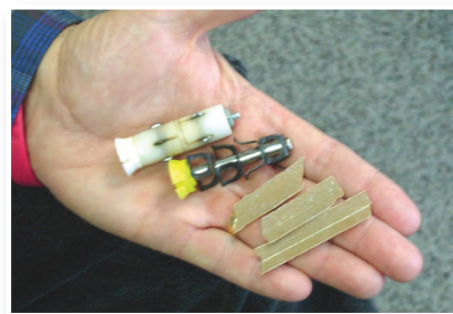
Calcium carbonate scale removed by Conco specially engineered Tube Cleaners

A Nebraska Coal-Fired Plant noticed a significant rise in cooling water temperatures leaving their condensers. Tests showed that a severe insulating blanket of calcium carbonate averaging .02" in each of the more than 50,000 tubes in the plant's condensers. A Conco crew used patented Calbuster tube cleaners that feature carbide wheels in a two-stage design to fracture the scale and break its bond with the tube surface. Once the calcium scale was fractured, the final operation was shooting a Conco C35 heavy-duty cleaner through each tube, removing the accumulated scale deposit. Tubes were cleaned to their base metal and polished by the C35 cleaners during the cleaning process. In all, 18,000 pounds of calcium carbonate scale deposits were removed from the condenser tubes. Plant engineers estimated that overall savings exceeded \$1.5 Million dollars per year.

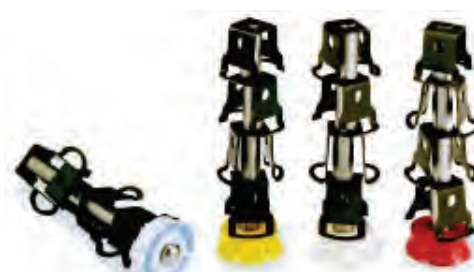
C4S Tube Cleaners

A 449 MW coal-fired power plant in Zolling, Germany, sought assistance in improving unit performance that was negatively impacted by fouled condenser tubes. The plant contacted the European office of Conco Systems, and a crew was quickly dispatched to the plant. Shooting Conco spring-loaded metal cleaners, the Conco crew removed fouling from the condenser's 40,000 brass tubes. After returning the unit to service, plant personnel noticed an immediate improvement in plant heat rate to the tune of 1.5%, and estimated that coal consumption would be reduced to the tune of €1,000,000 Euros annually, or the equivalent of \$1.3 million dollars!
